Service Publication for the Kodak Ektachem DTSC MODULE

Kodak Ektachem DTSC MODULE General Information Section 1

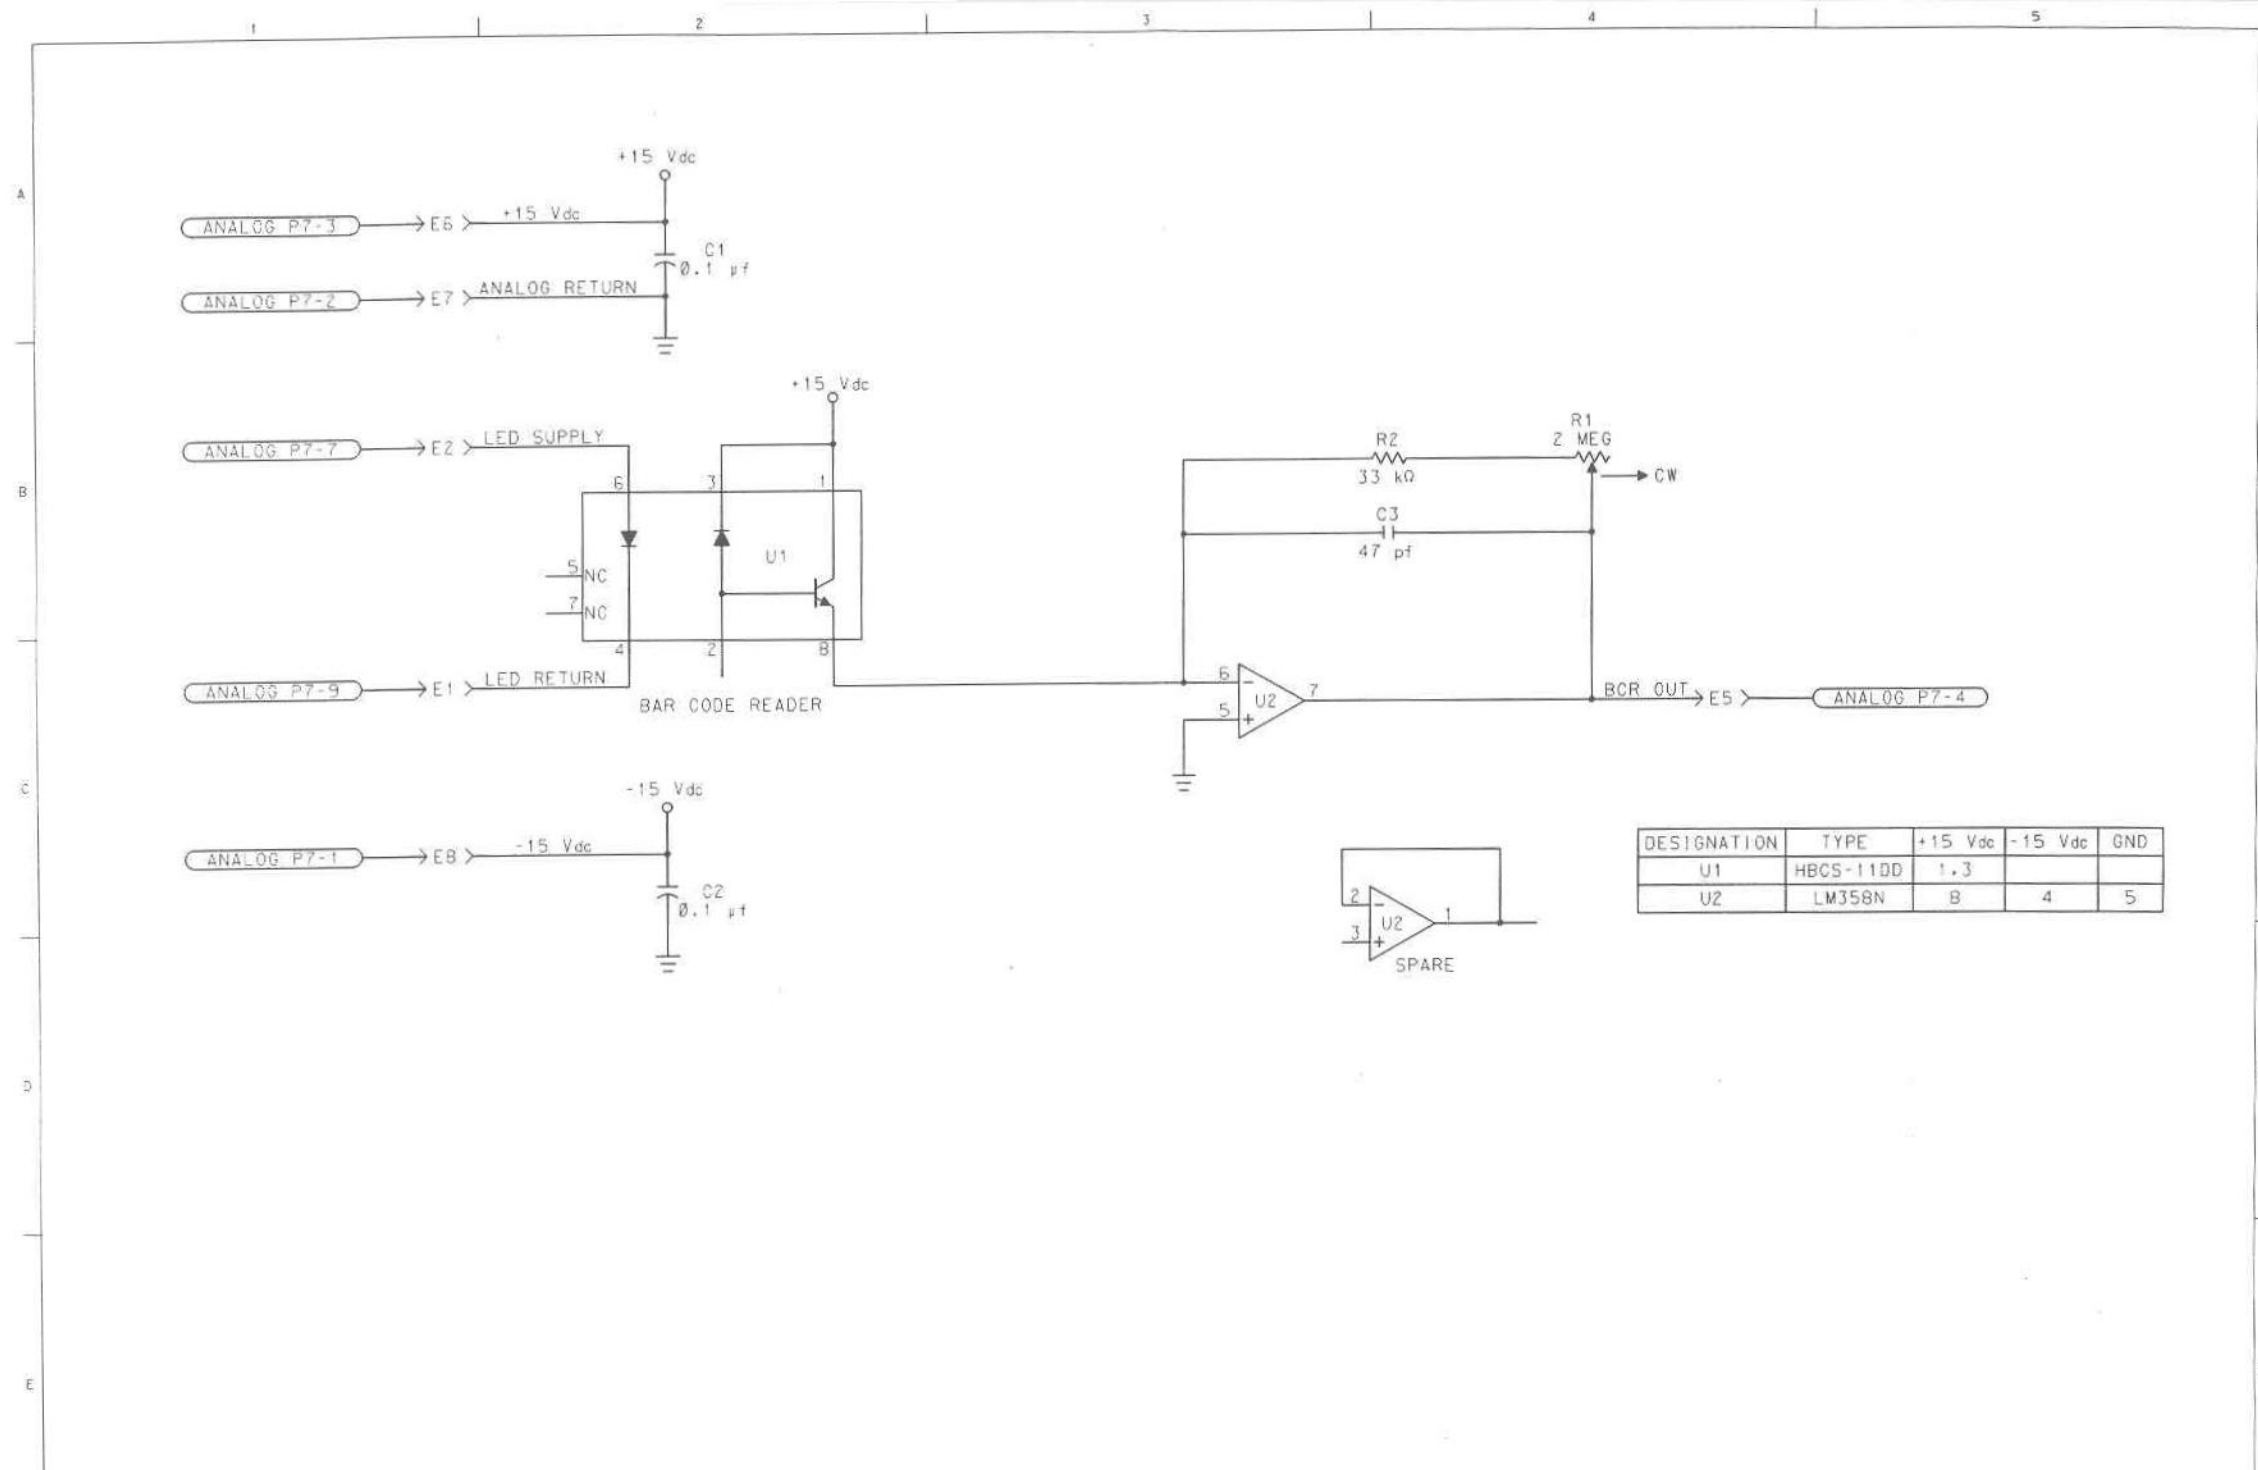
Figure 7 BAR CODE READER BOARD

DESIGNATION	TYPE	+15 Vdc	-15 Vdc	GND
U1	HBCS-110D	1,3		
U2	LM358N	8	4	5

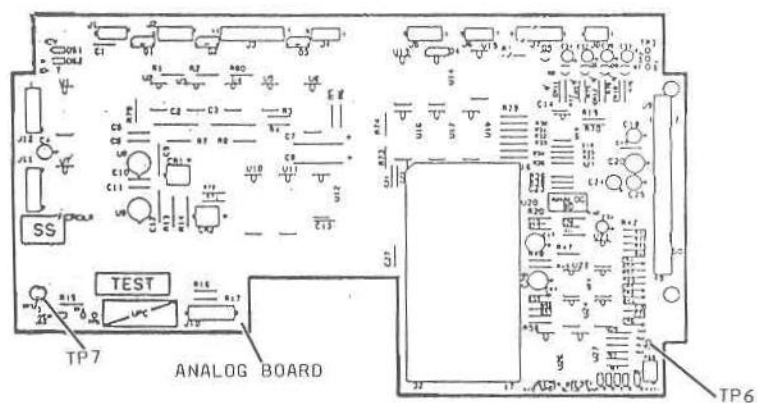
[8] Connect the MULTIMETER TL-3424 and advance to step 10.

MULTIMETER TL-3424	
+	-
TP 6 on ANALOG BOARD	TP 7 on ANALOG BOARD

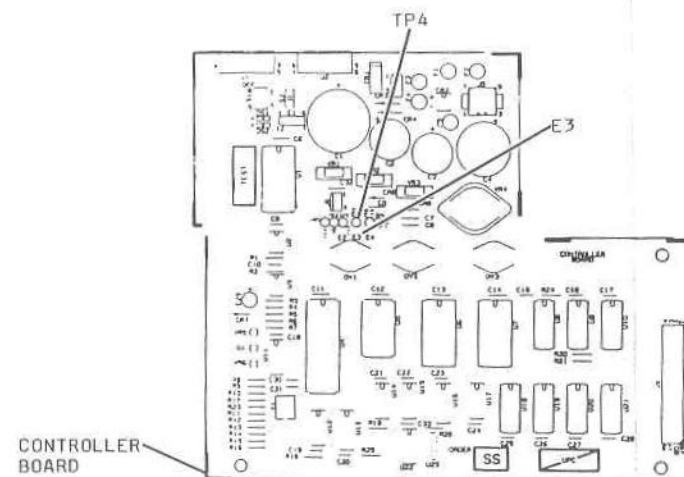
[9] Connect the MULTIMETER TL-3424.

MULTIMETER TL-3424	
+	-
TP 6 on ANALOG BOARD	TP 4 or E3 on CONTROLLER BOARD

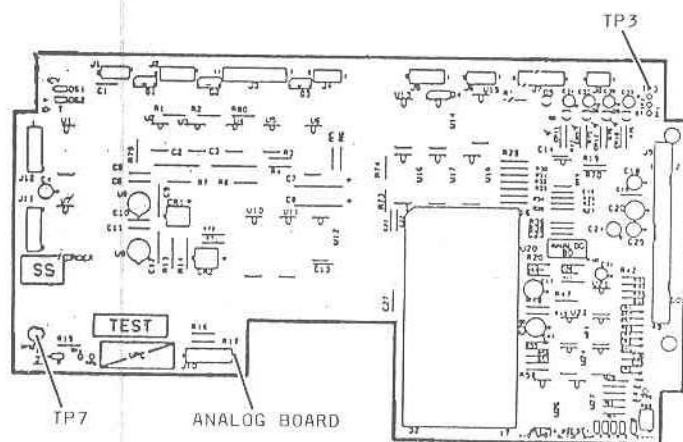
[5] Connect the MULTIMETER TL-3424 and advance to step 7.

MULTIMETER TL-3424	
+	-
TP 3 on ANALOG BOARD	TP 7 on ANALOG BOARD

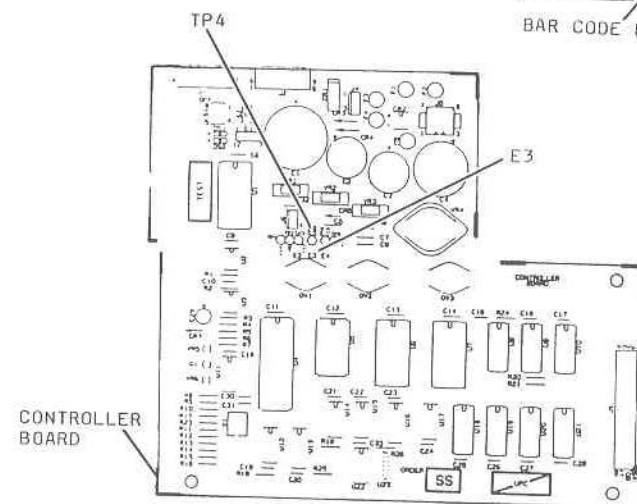
[6] Connect the MULTIMETER TL-3424 and advance to step 7.

MULTIMETER TL-3424	
+	-
U2-7 on BAR CODE READER BOARD	TP4 or E3 on CONTROLLER BOARD

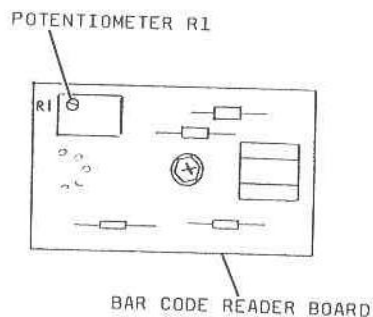
- [10] Rotate POTENTIOMETER R1 on the BAR CODE READER BOARD until you obtain a voltage reading of -5.75 to -6.25 V dc.

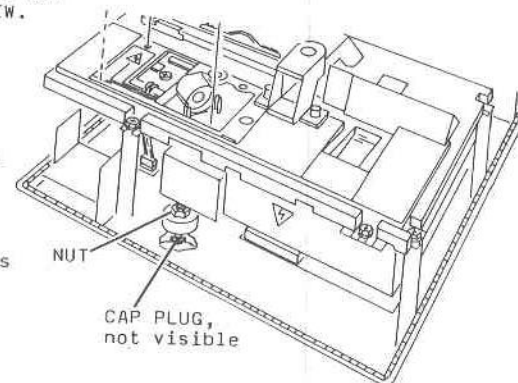
[5] Rotate the JACK SCREW counterclockwise 3 full rotations.

[6] Rotate the JACK SCREW clockwise until it makes contact with the FLASH ASSEMBLY.

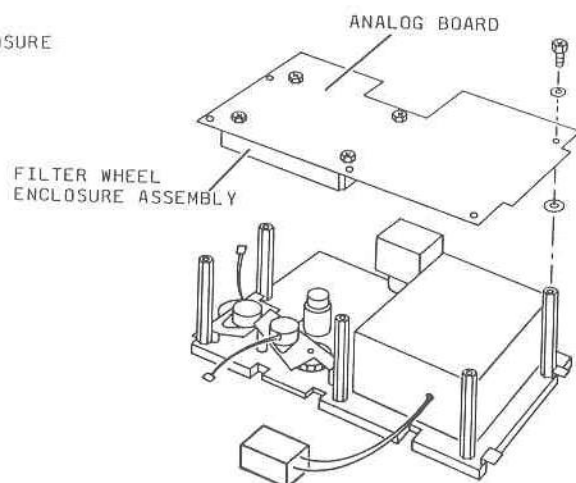
- ANALOG BOARD
- FILTER WHEEL ENCLOSURE ASSEMBLY

[3] Loosen the 2 SCREWS.

[4] Move the DRIVE MOTOR toward the FILTER WHEEL to engage the PINION GEAR and the FILTER WHEEL GEAR.

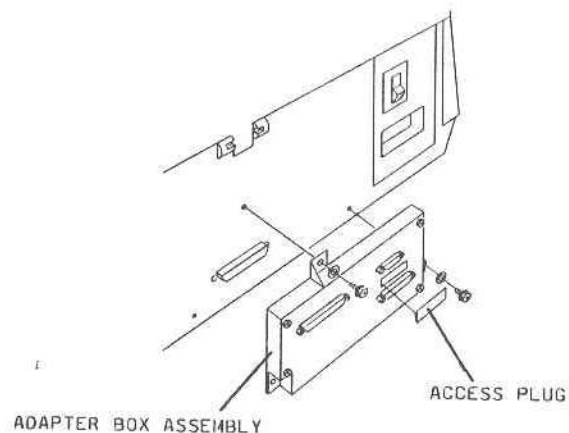
[5] To make the PORT on the ANALYZER compatible to the customer's computer, do the following:

- Ask the customer if the computer specifications are for DCE no handshake, DCE handshake, or DTE?
- Remove the ACCESS PLUG from the ADAPTER BOX ASSEMBLY.
- Place the JUMPER in the correct position.
- Install the ACCESS PLUG.

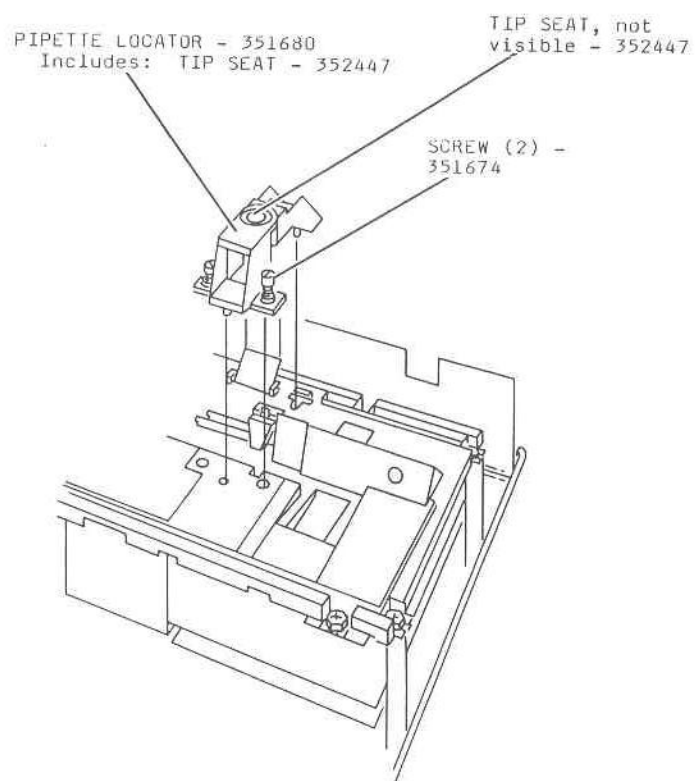
Figure 13

Adjustment specification for the height of the TIP

Specification: 0.086 to 1.02 mm (0.034 to 0.040 in.) from TIP to slide

- [1] Open the OPERATOR ACCESS COVER.
- [2] Loosen the 2 SCREWS.
- [3] Remove the PIPETTE LOCATOR.

- MAIN COVER ASSEMBLY, see figure 12
- PIPETTE LOCATOR, see figure 13

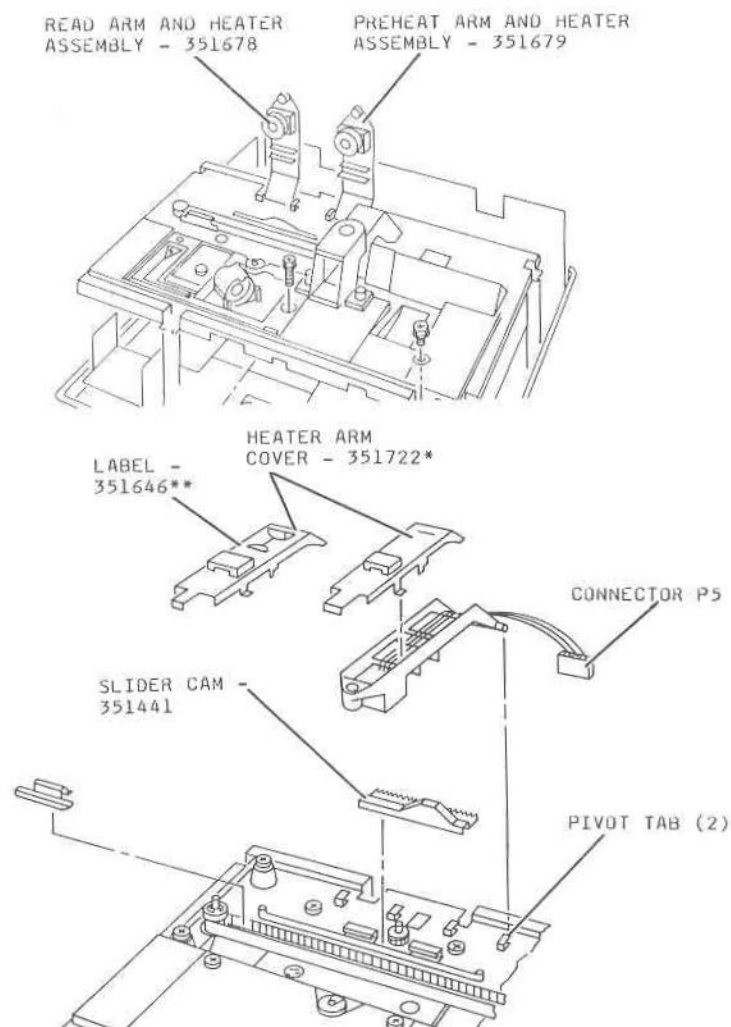
Figure 16

To remove the READ ARM AND HEATER ASSEMBLY or PREHEAT ARM AND HEATER ASSEMBLY

- [1] Place the ARM in an almost horizontal position and insert one side and then the other side under the PIVOT TABS.
- [2] Connect CONNECTOR P2 or P5 on the ANALOG BOARD.
- [3] Install the MAIN COVER ASSEMBLY. See figure 12.
- [4] Install the SPRINGS on the ARMS.
- [5] Do the D_R procedure.

- [1] Remove:
 - MAIN COVER ASSEMBLY, see figure 12
 - PIPETTE LOCATOR, see figure 13
 - READ ARM and PREHEAT ARM, see figure 16
- [2] Remove the 2 SCREWS and move the SENSOR BRACKET toward the back of the DTSC MODULE. See figure 14.
- [3] Loosen the SCREW 793714.
- [4] Loosen the ADJUSTMENT SCREW 793702.
- [5] Remove the BELT.

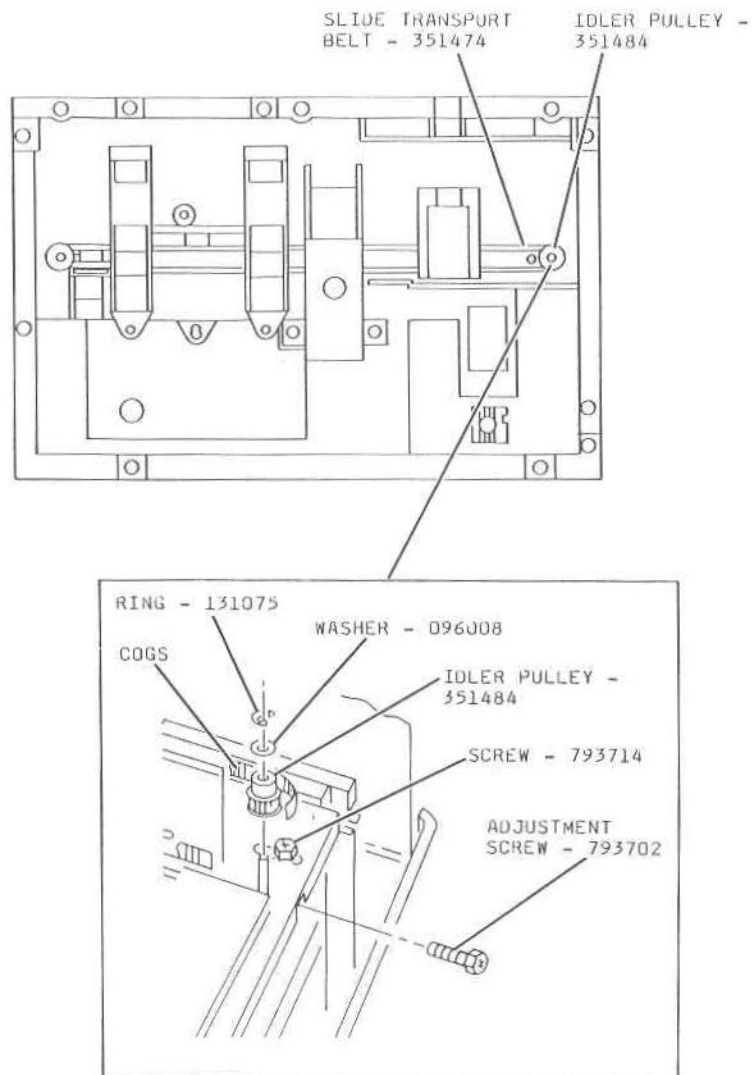
Figure 17

To remove the SLIDE TRANSPORT BELT

[2] Remove the SLIDE TRANSPORT BELT to prevent damage to it and to the SLIDE TRANSPORT CLIP. See figure 17.

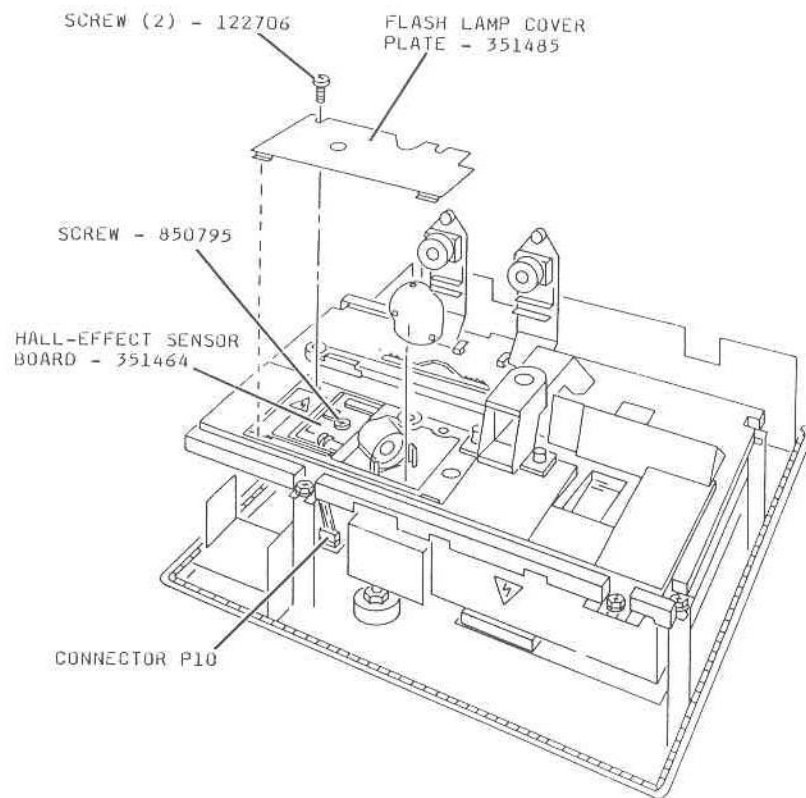
Figure 20

To remove the HALL-EFFECT SENSOR BOARD

- [1] Remove the MAIN COVER ASSEMBLY. See figure 12.
- [2] Move the READ ARM and the PREHEAT ARM up.
- [3] Remove:
 - 2 SCREWS 122706
 - FLASH LAMP COVER PLATE
 - SCREW 850795
- [4] Disconnect CONNECTOR P10 from the ANALOG BOARD.
- [5] Remove the HALL-EFFECT SENSOR BOARD.

LED DS3	OPERATOR ACCESS COVER
ON	down
OFF	up

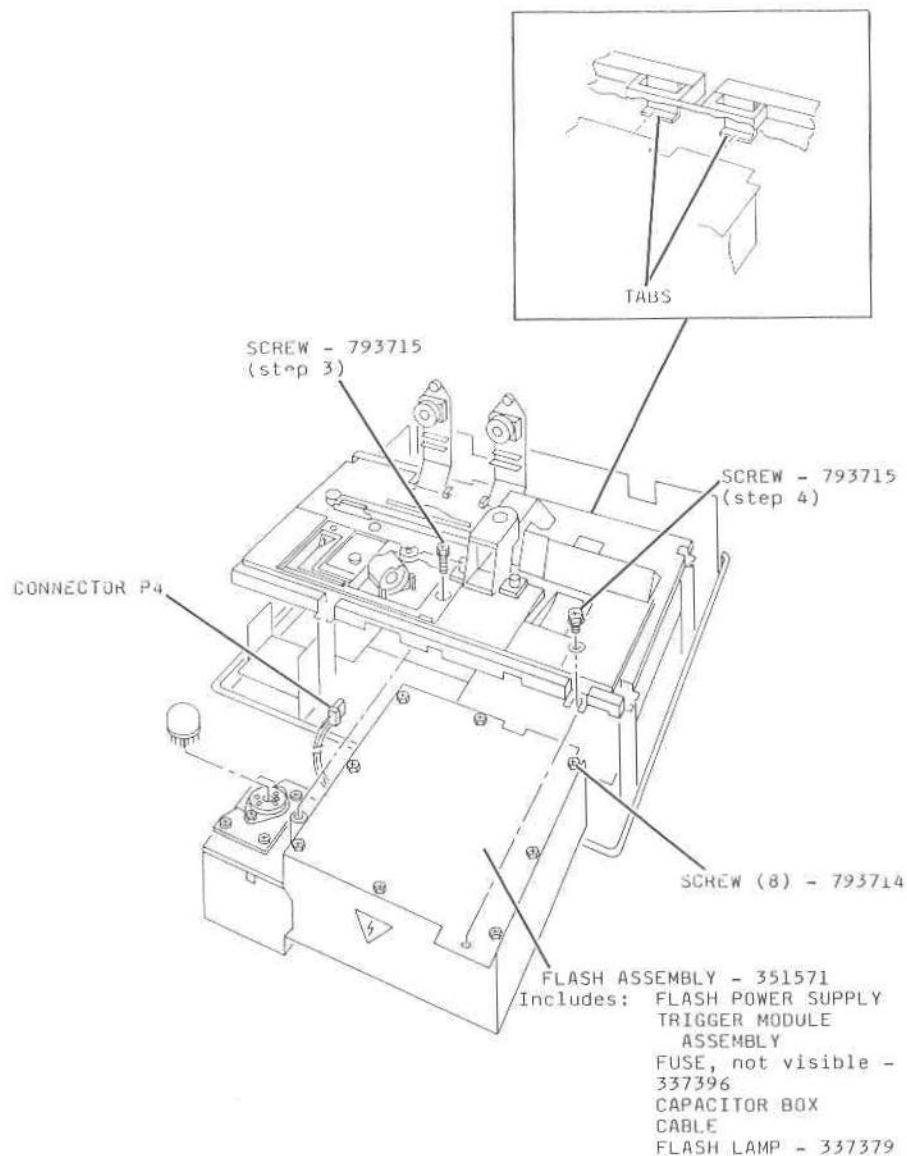
Figure 22

To remove the FLASH ASSEMBLY with CAPACITOR BOX

- [1] Move the MAIN POWER SWITCH to "0".
- [2] Remove:
 - MAIN COVER ASSEMBLY, see figure 12
 - READ ARM and PREHEAT ARM, see figure 16
 - TRACK SUBASSEMBLY, see figure 23
- [3] Remove the SCREW 793715 adjacent to the FLASH LAMP.
- [4] Loosen the SCREW 793715 in the right front corner.
- [5] Place the TRACK SUBASSEMBLY upside-down on the SUPPORTS.
- [6] Remove the ANALOG BOARD. See figure 24.
- [7] Move the FLASH ASSEMBLY and connected CAPACITOR BOX away from the TRACK SUBASSEMBLY.

- [1] Move the MAIN POWER SWITCH to "0".
- [2] Remove:
 - MAIN COVER ASSEMBLY, see figure 12
 - FLASH LAMP COVER PLATE, see figure 21
 - FLASH LAMP COVER, see figure 21
- [3] Remove the SCREW 793715 adjacent to the FLASH LAMP.
- [4] Loosen the SCREW 793715 in the right front corner.
- [5] Disconnect CONNECTOR P4 from the CONTROLLER BOARD.
- [6] Move the FLASH ASSEMBLY toward the front of the DTSC MODULE and remove it.

- MAIN COVER ASSEMBLY, see figure 12
- READ ARM and PREHEAT ARM, see figure 16
- FLASH ASSEMBLY, see figure 22
- TRACK SUBASSEMBLY, see figure 23
- ANALOG BOARD, see figure 24

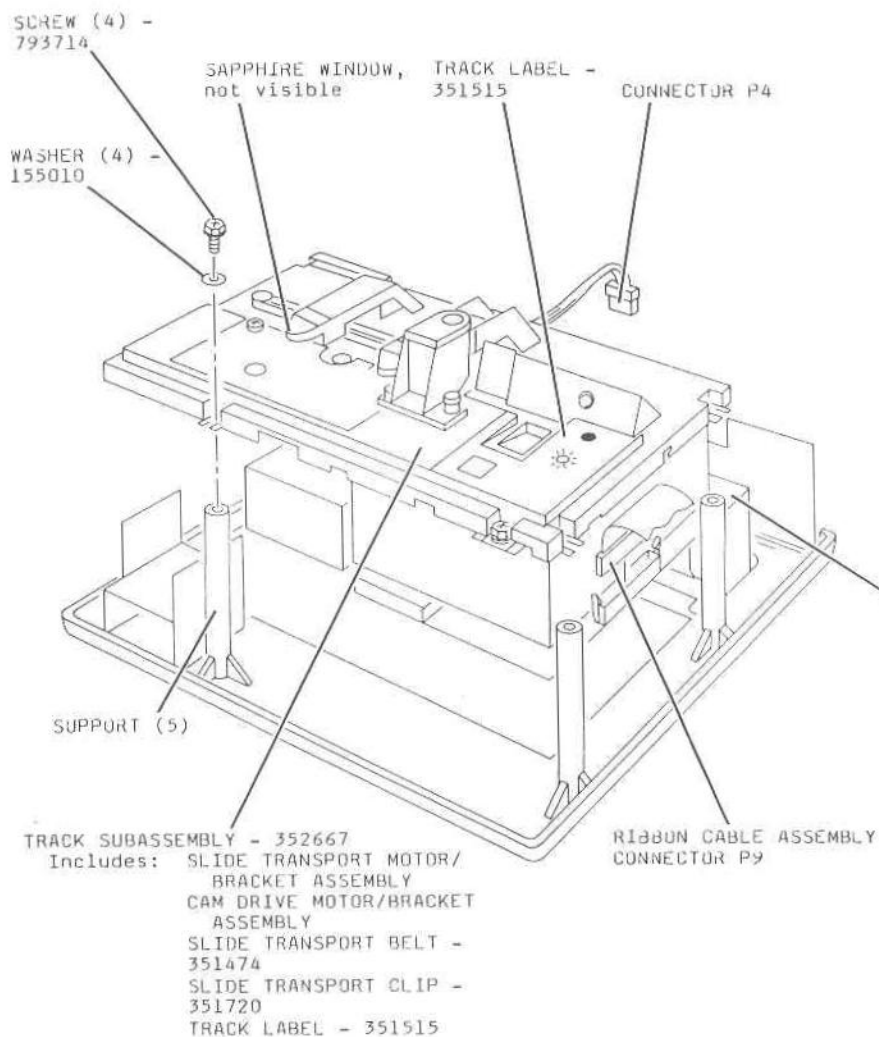
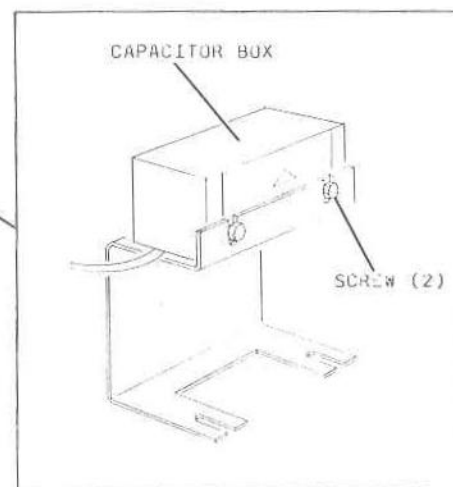
Figure 23

To remove the TRACK SUBASSEMBLY

- [1] Remove the MAIN COVER ASSEMBLY. See figure 12.
- [2] If necessary, loosen the 2 SCREWS and remove the CAPACITOR BOX.
- [3] Remove the 4 SCREWS and 4 WASHERS.
- [4] Disconnect:
 - RIBBON CABLE ASSEMBLY CONNECTOR P9
 - CONNECTOR P4 from the CONTROLLER BOARD

- [5] Lift the TRACK SUBASSEMBLY vertically above the 5 SUPPORTS and remove the TRACK SUBASSEMBLY.

- MAIN COVER ASSEMBLY, see figure 12
- READ ARM AND HEATER ASSEMBLY, see figure 16
- TRACK SUBASSEMBLY, see figure 23

- MAIN COVER ASSEMBLY, see figure 12
- READ ARM and PREHEAT ARM, see figure 16
- TRACK SUBASSEMBLY, see figure 23

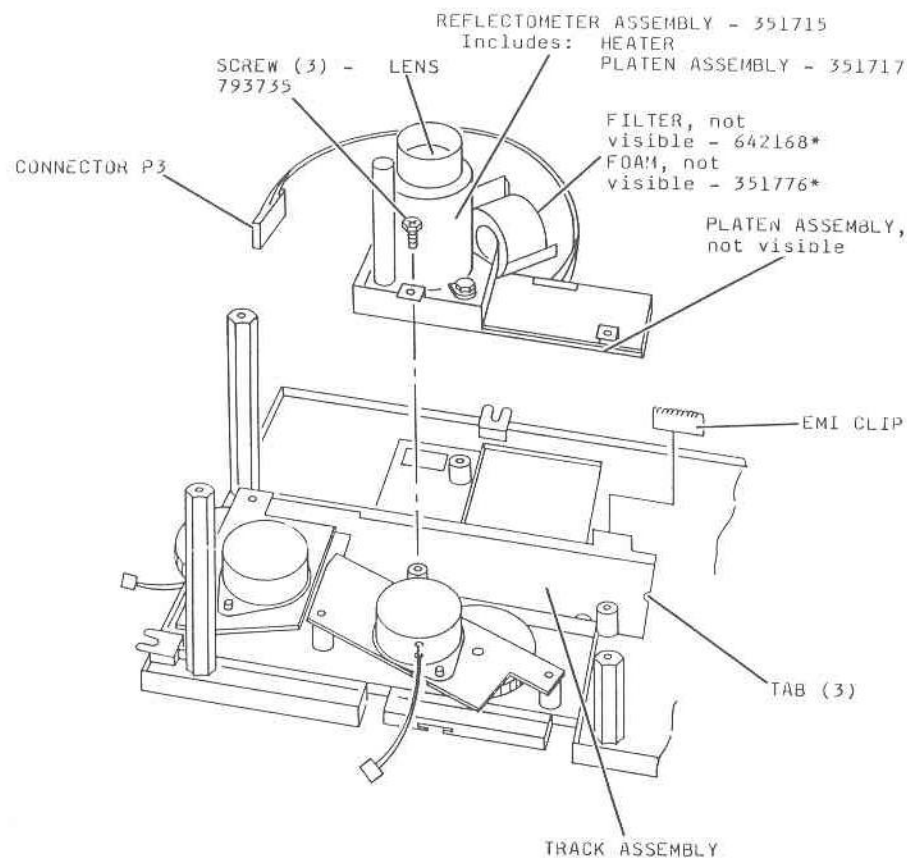
Figure 26a

* Modification No. M1. Installed in manufacturing on serial number 62000665 and above.

- [1] Remove the REFLECTOMETER ASSEMBLY. See figure 26a.
- [2] Remove the SCREW.
- [3] Move the HEATER PLATEN ASSEMBLY from under the TAB.
- [4] Lift the PLATEN ASSEMBLY ↑ from the TAB.

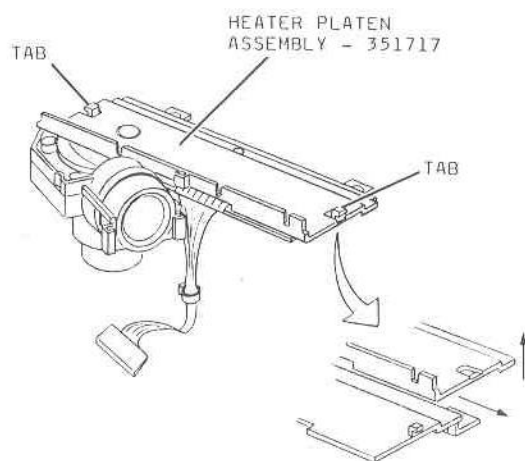
Figure 26b

To remove the HEATER PLATEN ASSEMBLY

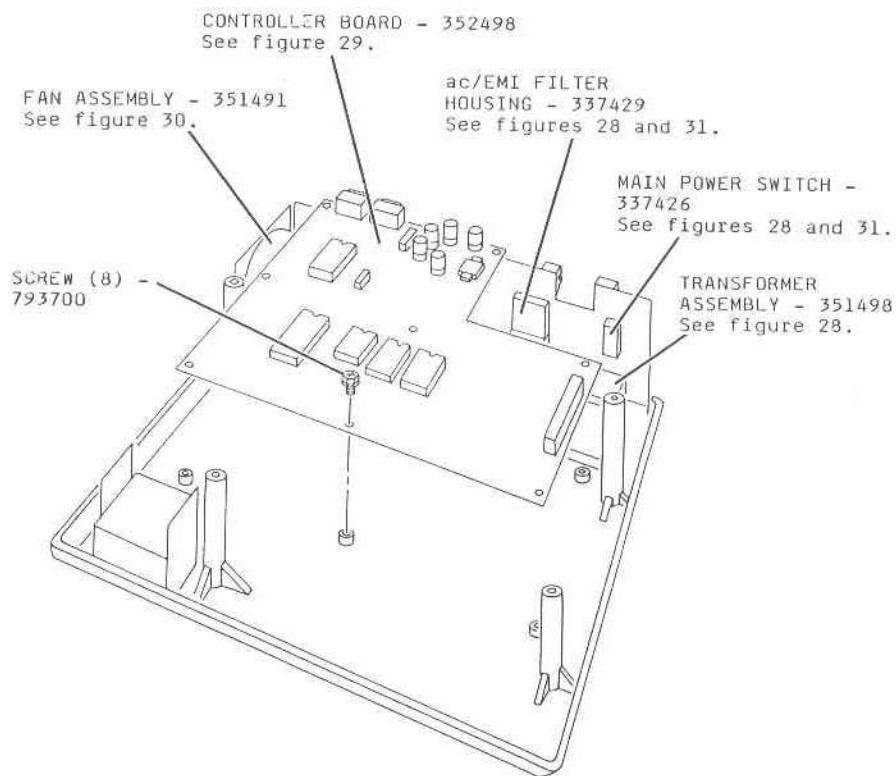
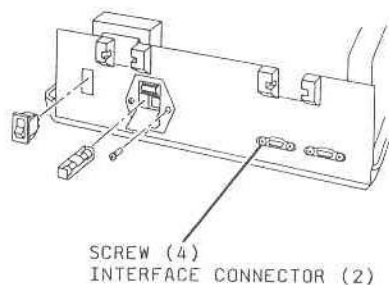
Figure 27

To remove the CONTROLLER BOARD

- [1] Remove:
 - MAIN COVER ASSEMBLY, see figure 12
 - TRACK SUBASSEMBLY, see figure 23
- [2] Remove:
 - 4 SCREWS from the 2 INTERFACE CONNECTORS
 - 8 SCREWS 793700
- [3] Disconnect CONNECTORS P5 and P6 from the CONTROLLER BOARD.
- [4] Move the CONTROLLER BOARD toward the front of the DTSC MODULE and from under the FAN ASSEMBLY.

- [1] Place the CONTROLLER BOARD in the correct position.
- [2] Install:
 - 4 SCREWS for the INTERFACE CONNECTORS
 - 8 SCREWS
- [3] Connect CONNECTORS P5 and P6.
- [4] Install:
 - TRACK SUBASSEMBLY
 - MAIN COVER ASSEMBLY

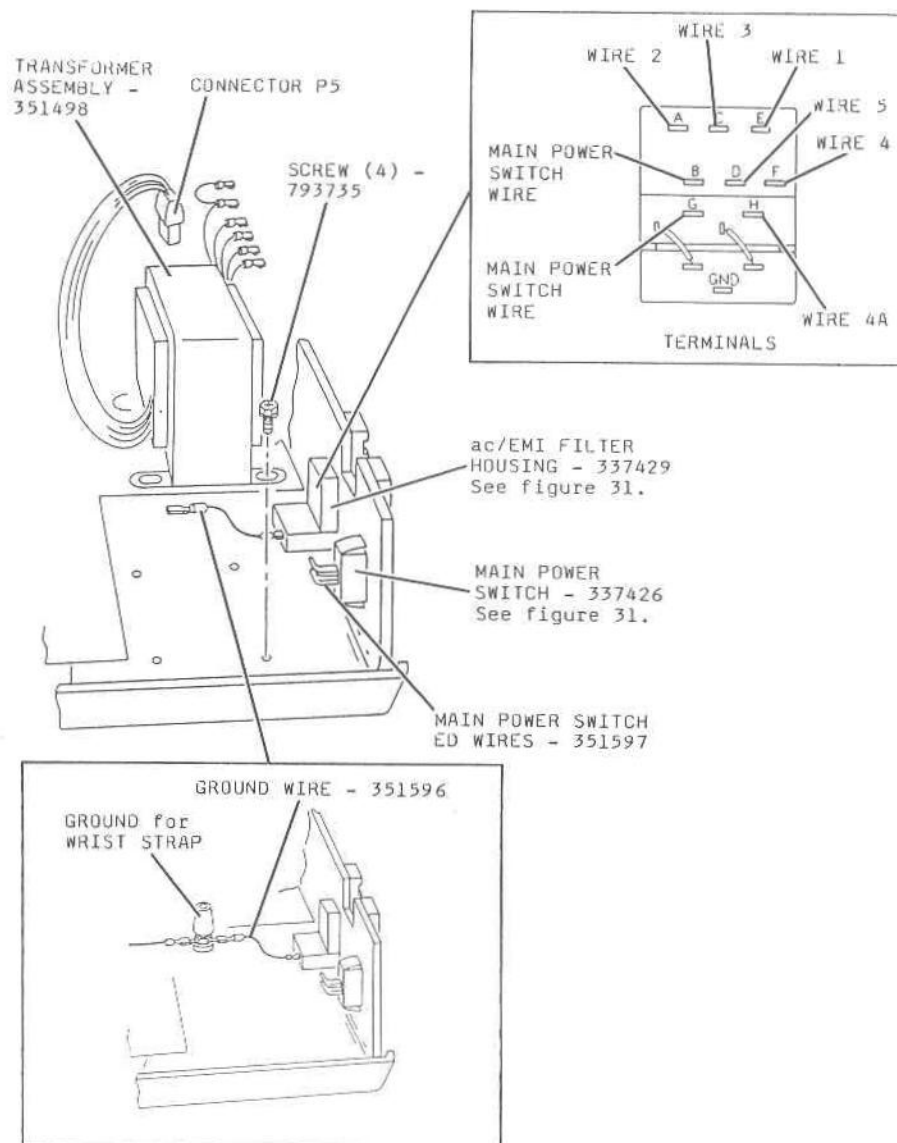
Figure 28

To remove the TRANSFORMER ASSEMBLY

- [1] Disconnect the POWER CORD for the DTSC MODULE.
- [2] Remove:
 - MAIN COVER ASSEMBLY, see figure 12
 - TRACK SUBASSEMBLY, see figure 23
- [3] Remove the 4 SCREWS 793735
- [4] Remove the CAPACITOR BOX SUPPORT.
- [5] Disconnect:
 - CONNECTOR P5 from the CONTROLLER BOARD
 - ALL TERMINALS to the ac/EMI FILTER HOUSING
- [6] Remove the TRANSFORMER ASSEMBLY.

The TERMINALS must be connected correctly.
Reverse the above procedure.

The TERMINALS must be connected correctly. See figure 28.
Reverse the above procedure.

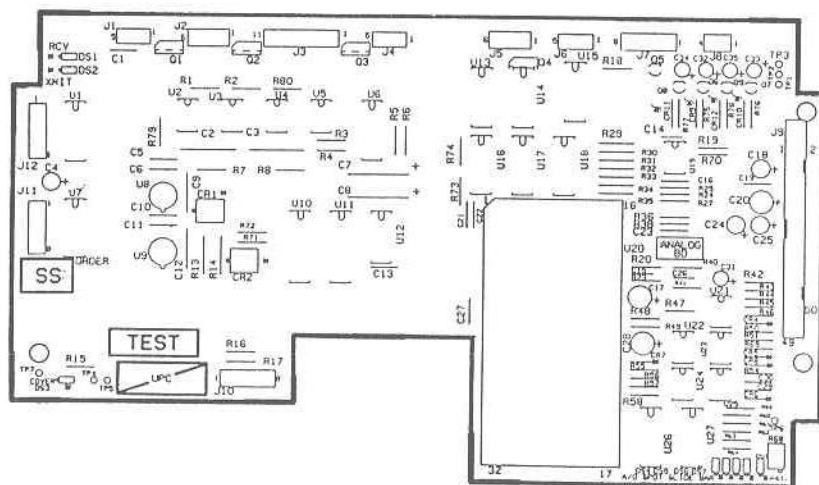
Figure 32 ANALOG BOARD without "PIGGY BACK" BOARD - 352391

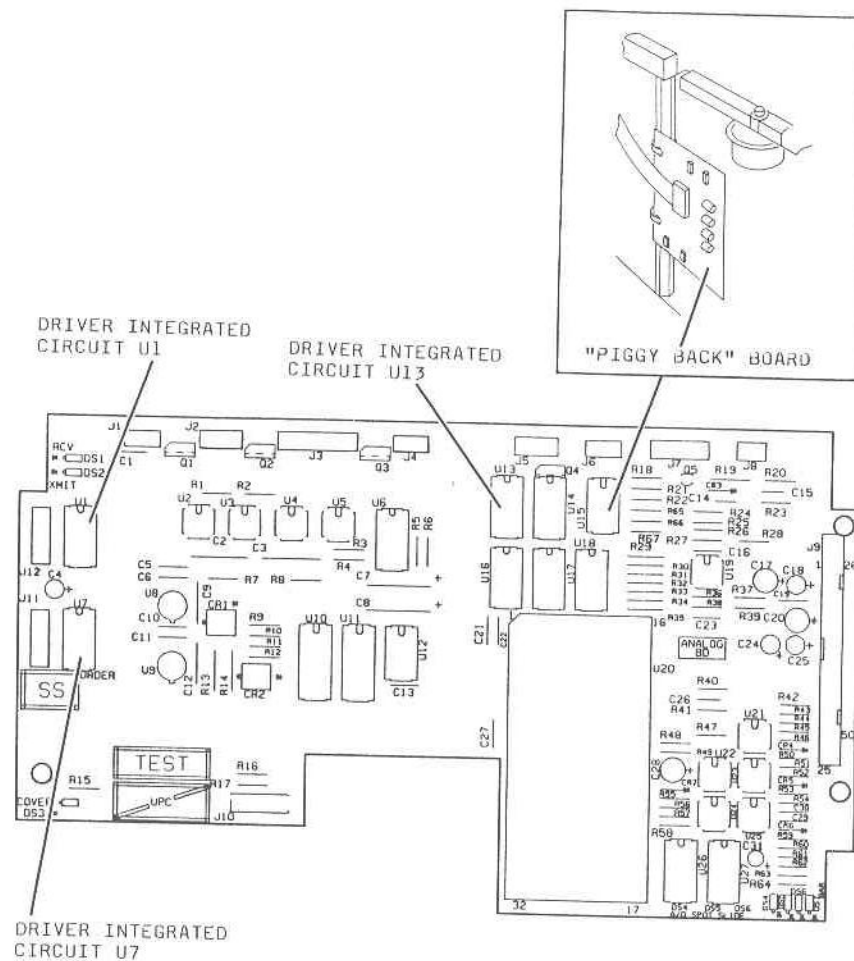
Figure 33 ANALOG BOARD with "PIGGY BACK" BOARD - 351461

[6] If necessary, disconnect the CONNECTOR for the "PIGGY BACK" BOARD from U15 on the ANALOG BOARD. See figure 33.

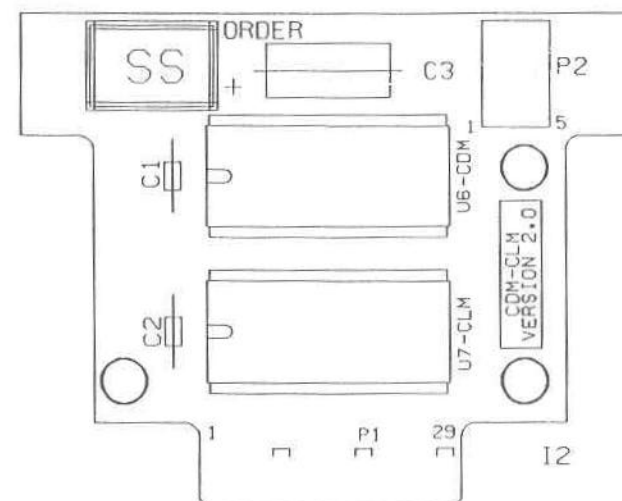
Figure 39 CDM/CLM BOARD - 351445
